A SURVEY OF AUSTRALIAN CONTAINER PORT PAVEMENTS SURFACED WITH CONCRETE SEGMENTAL PAVING

Shackel, B., Pearson, A. and Holt, W.

School of Civil and Environmental Engineering, University of New South Wales,
Queensland, Australia.

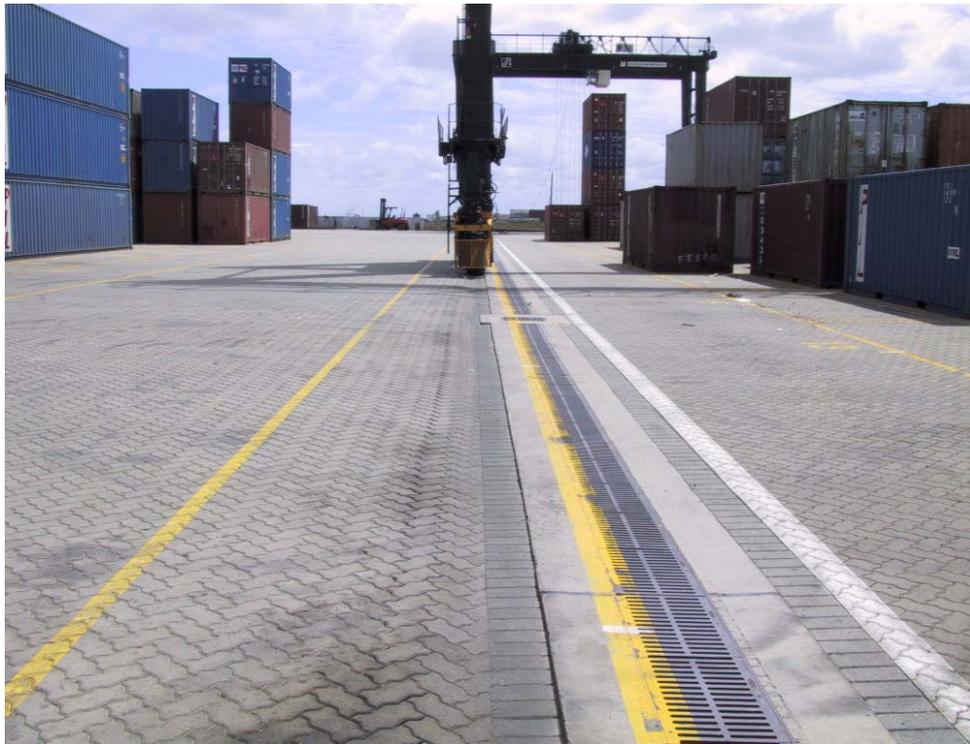
By referring to Figure 1 it may be seen that, for the pavement shown in Figure 2, the orientation of the herringbone pattern to the left of the drain with respect to the dominant direction of trafficking was the least advantageous possible. Here, rotation of the bond through 90° would have acted to reduce rutting under traffic caused by the transtainer. Inconsistently, the pattern show to the right of the drain in Figure 2 is optimally aligned for transtainers or straddle carriers moving along the container rows. Although the pavements were not specifically designed for transtainer operation this demonstrates the need to take care when establishing the orientation of laying patterns during design and construction and is discussed further below.

Figure 2. Pavement to right of drain is optimally orientated for straddle carriers whilst pavement to left is sub-optimal for the transtainer movements.

Soldier courses of rectangular pavers have also been used along slot drains and at yard entrances. Sometimes this has caused problems. For example, as shown in Figure 2, the soldier course may be seen to have been installed along the wheel path of a transtainer. This cannot be considered a good detail because, as noted above, it is documented (e.g. Shackel, 1990) that both rectangular pavers and stack bonds are associated with poor performance under traffic. Consequently pavers in the soldier course rotate and creep under traffic. Overall, based on this study it must be concluded that the use of pavement details developed for roads are not generally suitable for industrial pavements and more specific details need to be redesigned

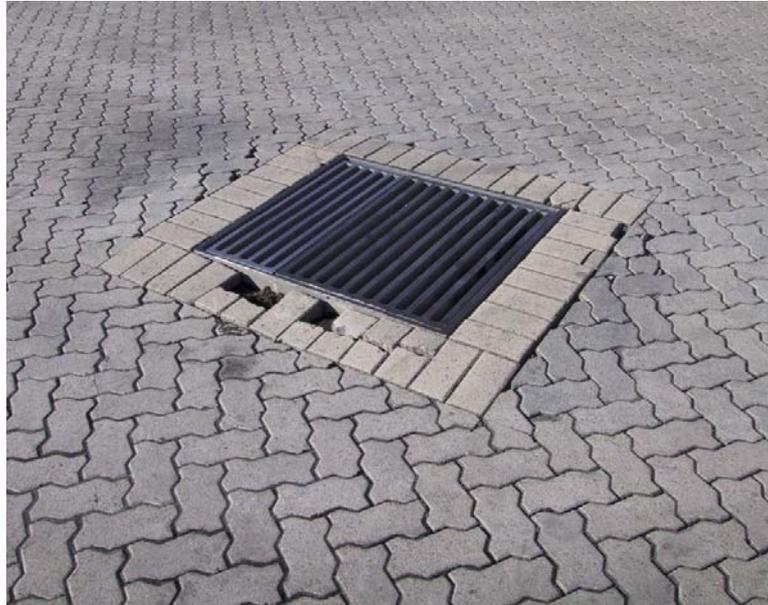
In addition to settlement problems, pit surrounds have often been damaged by a combination of settlement and traffic. A common detail, adopted from road paving practice, in all the projects visited was to employ a soldier course of rectangular pavers around the pit. As for example shown in Figure 3, this detail does not perform well under heavy industrial loads or in areas of high settlement. In many places pavers had rotated and fractured and, in some instances, had been dislodged. New pit surround details, omitting the soldier course, need to be used for industrial segmental paving.

Figure 3. Damage to pit surrounds.

It appears that often compaction adjacent to pits in has been by Wacker Packer in contrast to the rollers used elsewhere on the pavements. This may have contributed to the differential movements observed at pits. This emphasizes the need to control both compaction and the choice of backfill materials adjacent to intrusions.

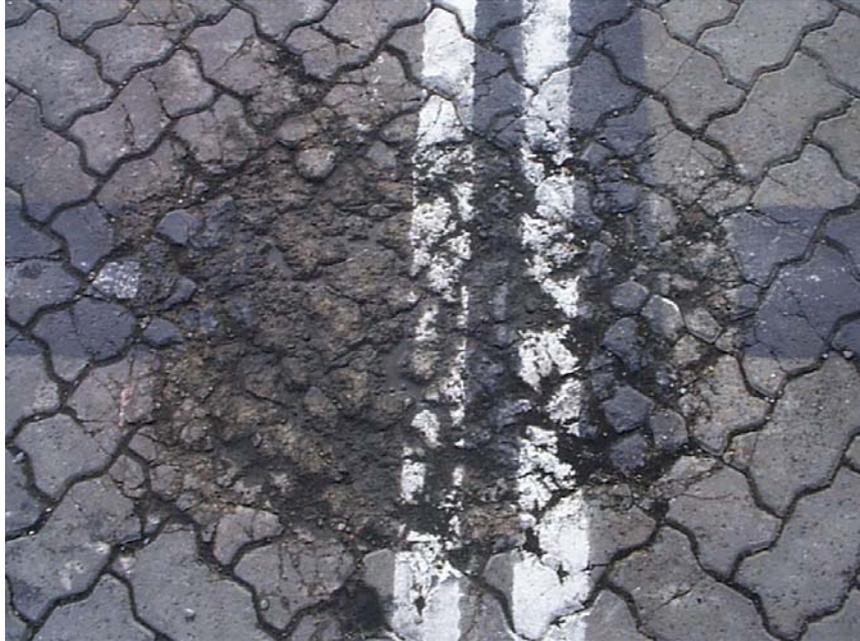
Worldwide it has been reported that no form of pavement including asphalt and reinforced concrete has proved immune to damage by containers. Indeed, in some European container yards such as the ECT, Rotterdam, it is common to eschew the use of any conventional surfacing and, instead, to use large sized crushed rock for container stacking. Judged by such criteria the damage observed in the Australian facilities was generally minor. The most severe example found during the study is illustrated in Figure 4.

Figure 4. Damage caused by container stacking.

Damage such as that shown in Figure 4 is largely cosmetic and can be completely and easily repaired if necessary, by removing and replacing just a small number of pavers. The sole impediment of serviceability is the tendency of the damaged areas to pond water. This, rather than the paver damage *per se*, provides the prime cause for maintenance to be required.
