Concor Technicrete (Pty) Limited

Summary:

This paper presents case studies of three projects, each of which had a different problem causing pavement failure. The paper will illustrate that, in the precast concrete paving industry in South Africa, there are still an alarming number of designers, specifiers, users, manufacturers, and contractors who do not understand the basic principles of concrete block paving technology.

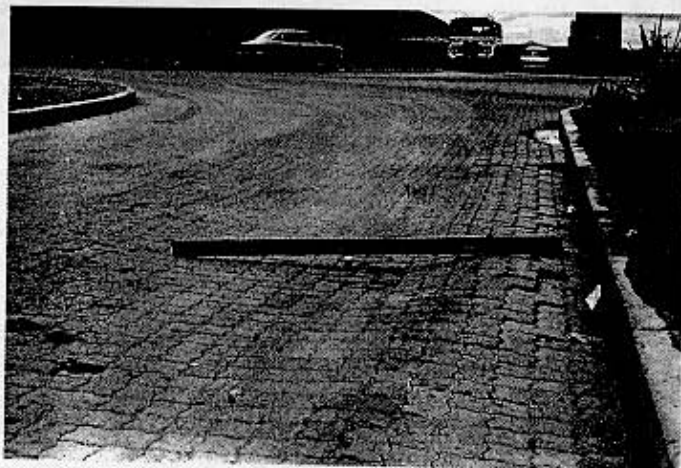
Work was completed in November 1986 and soon after the "truck inn" was opened to traffic the paving started showing signs of failure, which very rapidly deteriorated beyond acceptable norms.

The mode of failure were typical and included inter alia

i) Rutting where traffic is concentrated along specific routes, particularly in areas which were subjected to high traffic volumes.

ii) Chipping and spalling of the pavers in open areas where vehicles turn and manoeuvre.

- iii) Elastic deformation of the surface under the wheel loads.
- iv) Rotation and subsequent creep of the blocks in the badly affected areas.
- v) Opening up of joints thus destroying shear transfer between the blocks.

Figure (1) Extent of Failure

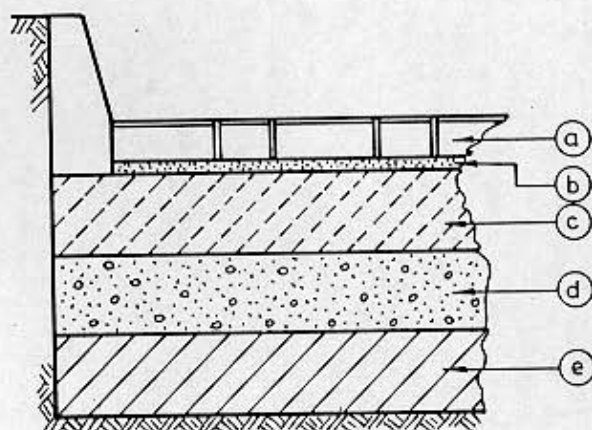
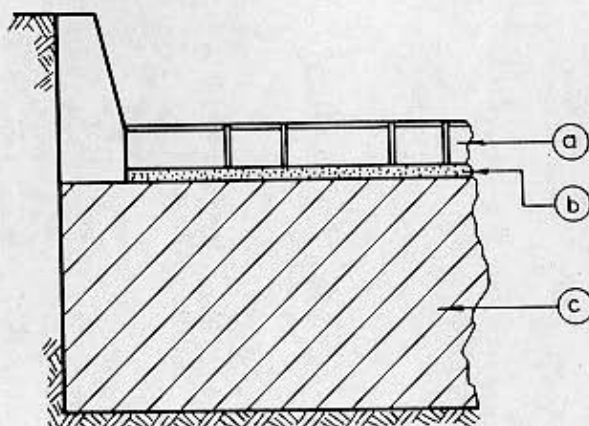
TABLE 1 - COMPARISON BETWEEN SPECIFIED AND CONSTRUCTED CRITERIA.

However the standard of workmanship in constructing the sub-surface earthworks was below even marginal limits. This together with the inferior materials used in the fill under the pavement and further aggravated by the fact that no sub-surface drainage was allowed for resulted in a complete breakdown of the integrity of the pavement.

AS SPECIFIED

AS CONSTRUCTED

- a) 80 mm interlocking concrete pavers
 b) 25 mm bedding sand
 c) 150 Stabilized natural gravel sub-base compacted to 95% mod AASHTO
 d) 150 selected natural gravel sub-base layer compacted to 93% mod AASHTO
 e) 150 mm thick in-situ sub-grade material scarified and re-compacted to 93% mod AASHTO

- a) 80 mm interlocking concrete pavers
 b) 20 mm bedding sand
 c) Moist light grey, dense micaceous slightly clayey fine sand-fill. Compacted to 93% mod AASHTO

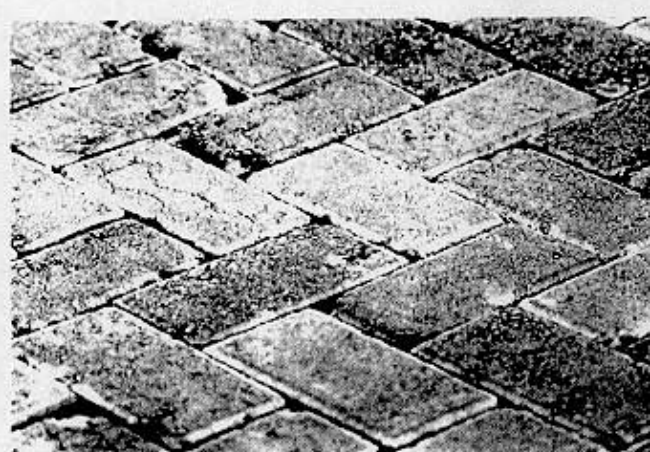
- i) The surface texture of the blocks was inconsistent (from very smooth to rough).
- ii) Several blocks were chipped and broken in half.
- iii) The alignment of the blocks was very poor.
- iv) The joint widths varied from 0 mm to 12 mm.
- v) Blocks were porous, losing colour, delaminating on the surface and the corners were chipped.
- vi) There were signs of rutting and evidence of subsidence.

Figure (3) Photograph showing typical defects

From the above it was clear that the blocks supplied by the Manufacturer to the site were completely unacceptable and were the cause of poor alignment and irregular joint spacing of the blocks, as observed in the completed pavement.

- (i) Blocks uplifted and removed from site.
- (ii) Existing base coarse material removed.
- (iii) A 100 mm thick layer of crusher-run (base coarse) relaid, and compacted to 98% mod MASHTO.
- (iv) 25 mm layer of bedding sand imported.

- (vi) New 60 mm coloured blocks, manufactured in accordance with CMA specifications, laid.

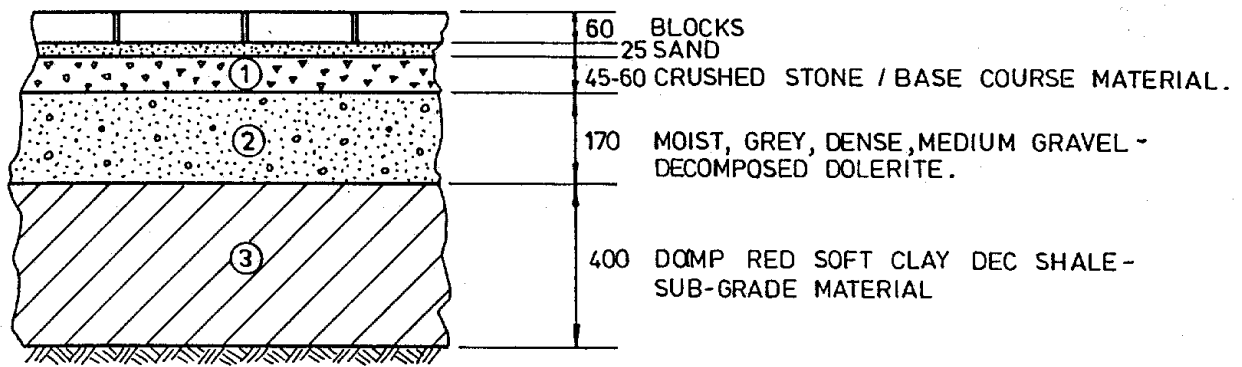
To investigate the settlement which had taken place five test holes were excavated at the site and a typical profile (section) of the side of the test hole, is shown in figure 4.

An examination of this profile revealed that the re-establishment of the base course had not met the minimum thickness of 100 mm specified

and it was concluded that this had contributed to the surface distortion that had taken place

Table (3) - Results of Laboratory tests on various layers (see figure 4).

Figure (4) - Typical profile of test hole
