P. Leenders

Rotterdam Public Works

Application as a foundation material below concrete block pavement was investigated in the pilot-project Vondelingenweg in Rotterdam.

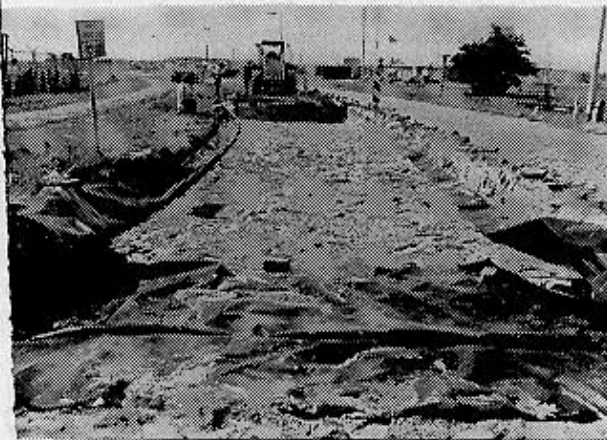
Figure 2 Overview during execution

the original blocks in the same road. The kerbs are made of concrete, cast in situ. Half the length of each test section (37.5 m) has a synthetic membrane between the sub-base and the foundation material. See figures 2 and 3. Drainage pipes carry the intercepted water to collection vessels at the roadside. See fig. 4 (cross-section) and fig. 5.

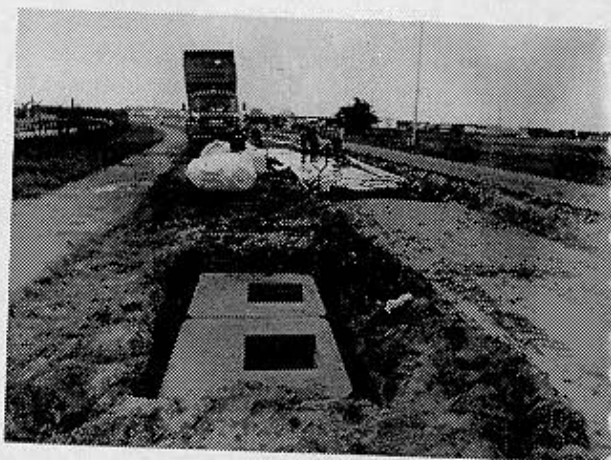
Figure 6 Collection vessels

The roadside collection vessels (figure 6) at the test sections with a synthetic membrane under the road foundation, allow the amount of rainwater which has drained from under each section, to be measured. The quantities are determined by the amounts pumped out using a flowmeter at the drain opening and syphon counting devices.
