AN EXAMPLE OF PAVEMENT REHABILITATION BY CONCRETE BLOCK PAVING IN EXPANSIVE OR COLLAPSIBLE SOIL REGIONS

Moshe Livneh & Karl Ruhm

Summary

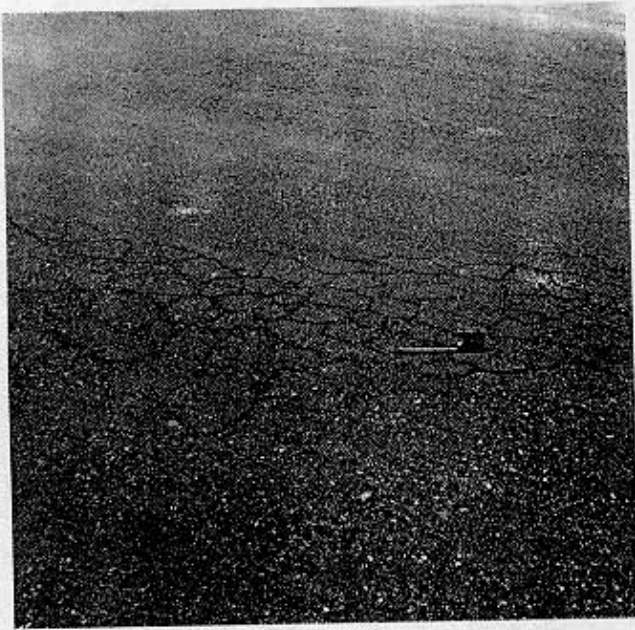
Figure 4. Cracking of rehabilitated asphalt surface at the access way to the junction.

Some of these failures still exist at the approaches to the rehabilitated junction and are shown in Figure 3. As shown in Figure 4, severe rutting associated with dense cracks appeared even in the recently rehabilitated section of the approach zone. This section is made up of a 5cm asphaltic layer constructed at the same time as the concrete blocks.

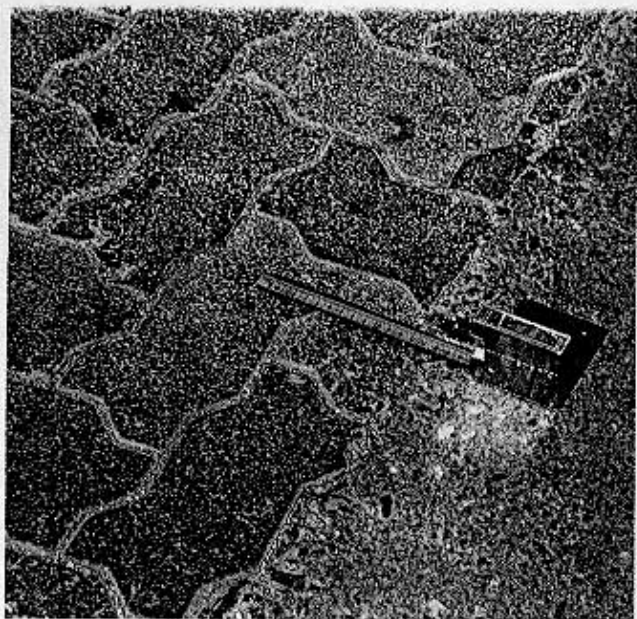
Figure 7. Close-up photograph of a successful joint solution between interlocking blocks and the existing asphalt surface.

In contrast to the above solution, a new solution using concrete block paving of 8cm Uni-type laid in a herringbone pattern, performed successfully. These blocks were laid after removing about 20cm of the existing pavement, using a new thin subbase course and a 3cm sand course, (see Figures 5 and 6 and 7).

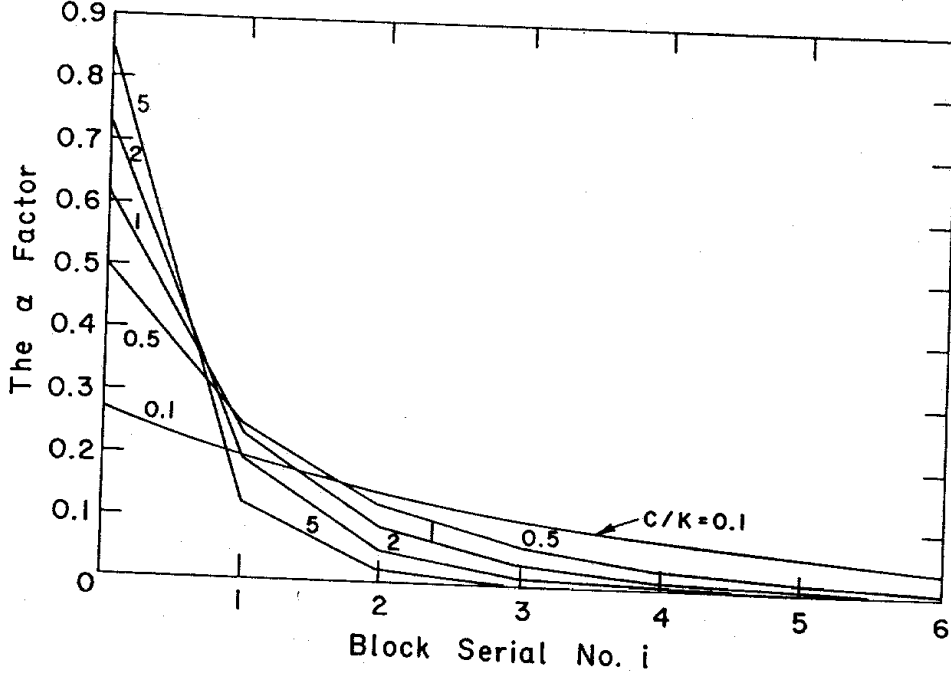
The α function for different values of C/K and different values of i (serial number of the blocks) is given in Figure 11. It has been derived from the equilibrium equations by solving the linear matrix with the aid of a PC.

Figure 11. Change of α factor with the proportion C/K and the serial number of the interlocking blocks.

when K is equal to infinity (a very rigid joint) δ_i equals zero. In other words, the whole beam is considered to be a continuous rigid beam. On the other hand, when K is equal to zero (a very loose joint), δ_0 equals P/cxL . In other words, in this case, there is no transfer of load from the inner part of the beam to the other blocks.
