A CASE HISTORY OF CONCRETE BLOCK PAVERS AT DUNDALK AND SEAGIRT MARINE TERMINALS

Thomas J. Shafer, Jr., PE

Moffatt & Nichol

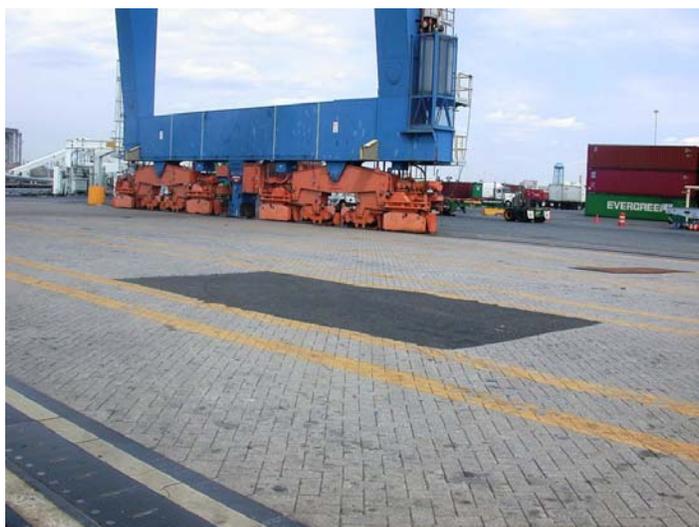
Figure 6. Seagirt Wharf Repairs

The wharf pavement has performed quite well over time. There is some settlement of the blocks adjacent to the pile-supported concrete beams of up to 25 mm. Some cracking and corner spalling of the blocks is also evident. Sinkholes have developed in several areas that are not underlain by the wharf relieving platforms and erosion of the underlying fill has occurred. In some instances, bituminous concrete patches have been installed to repair these areas instead of removing and relaying the pavers. Figure 6 shows the bituminous concrete spot repairs. MPA's annual maintenance contract includes line items for asphalt repair, but not CBP repair line items.

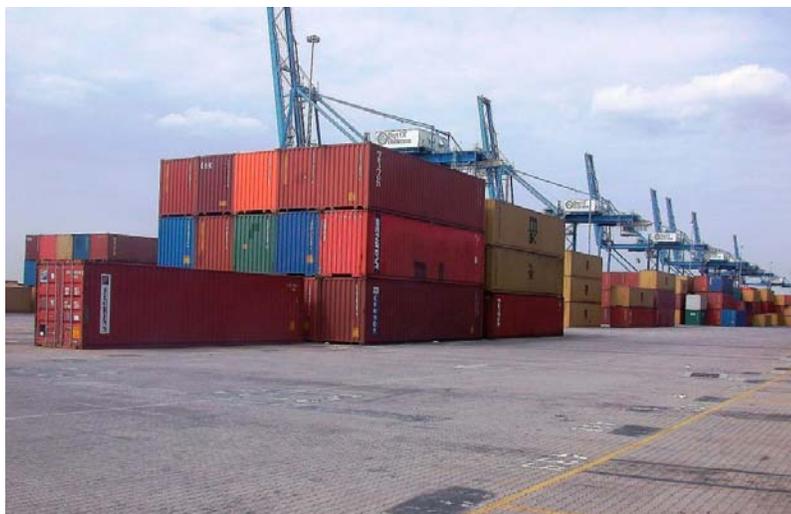
Figure 7. Toploader Operation in Berth 4

When the Berth 4 yard was brought on-line in 2001, this area was used primarily for wheeled storage with some stacking of containers by toploader. To provide more yard capacity to accommodate the growth of container cargo, the Operator implemented an all grounded operation using rubber tired gantry cranes (RTG's) to handle loaded import boxes, and toploaders to handle loaded export boxes and empties. A toploader stacking area is shown in Figure 7.

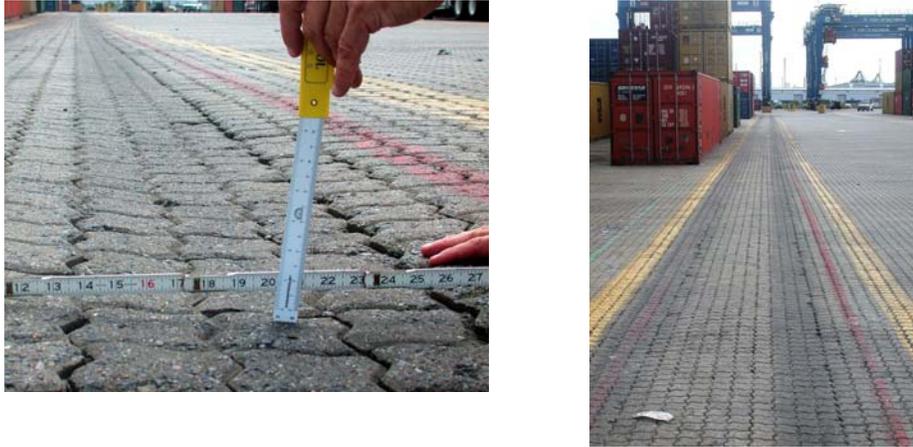
While the CBP pavement has performed very well under the wheeled and toploader operation, the RTG's have caused rutting of the CBP pavement similar to that observed in the modified asphalt surfaced areas. A typical rut along an RTG travel path is shown in Figure 8.

Figure 8. Rutting from RTG Operation

The MPA is in the process of removing the existing pavement and constructing 300 mm thick reinforced concrete runways along the RTG travel lanes in both the modified asphalt and CBP areas. The lesson learned is that in situations where the container handling equipment follows the same wheel path repetitively, a flexible pavement will invariably rut.

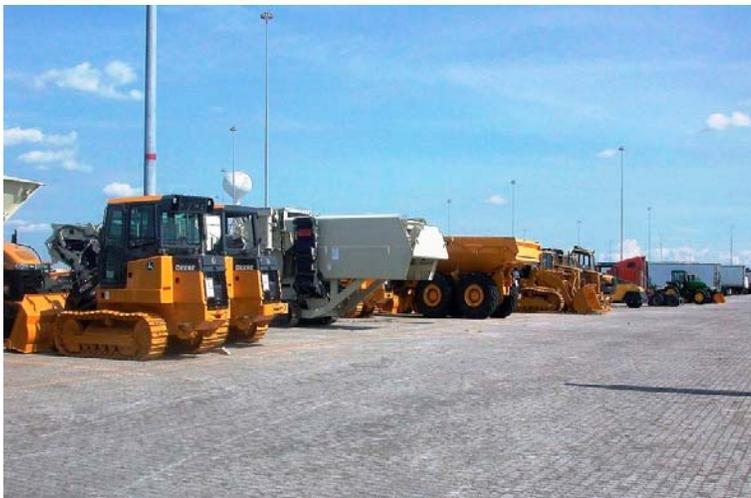
Figure 10 WW Yard Area Paved with CBP

The pavers were Uni-Anchorlock units supplied by Oldcastle (Balcon) and were mechanically placed by an Optimas laying machine. Construction was completed in 2002. A recent photo of the area behind Berth 8 (Figure 10) shows the wide range of cargoes handled at this facility.

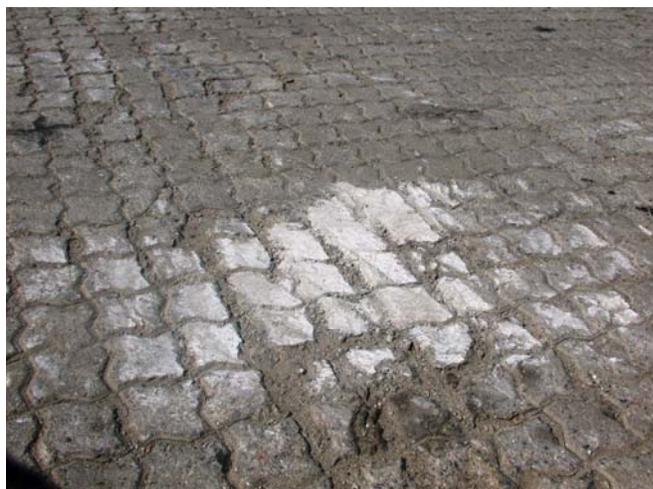
damage includes abrasion of the top surface and fracturing of the blocks. A distressed area behind Berth 8 is shown in Figure 11. A distressed area behind Berth 8 is shown in Figure 11.

The CBP pavement has performed well to-date; however, the wear caused by the turning movements of the tracked vehicles as they transit from the berth into the aisleways has caused some noticeable damage. The stress on the pavement is made worse by the facts that the tracked equipment makes locked track turns. This

Figure 11. Damage to CBP Pavement Caused by Tracked Equipment

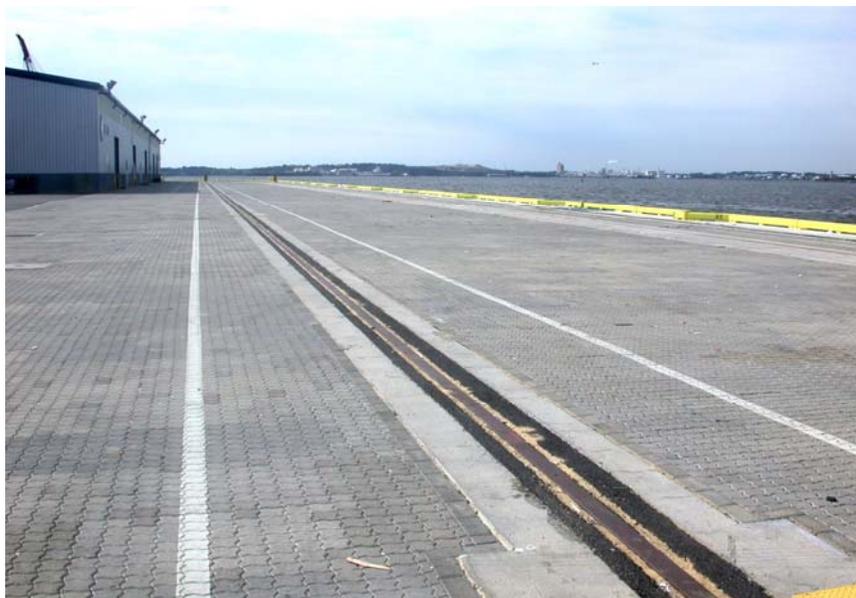
Based on the positive performance of the Seagirt Marginal Wharf, MPA elected to go with a CBP pavement. The wharf pavement section consists of 120 mm thick pavers over 25 mm sand bedding over 200 mm dense-graded aggregate.

The pavers are interlocking rectangular blocks supplied by Pavestone and placed both mechanically and manually. The CBP pavement covers approximately 4,046 m². A view of the CBP pavement at the Berths 5-6 wharf is shown in Figure 12.

Figure 12. CBP Pavement at Berth 5-6, DMT
