BEDDING SANDS FOR CONCRETE BLOCK PAVEMENTS SUBJECT TO HEAVY CHANNELISED LOADING

Anthony N.S. Beaty, Royal Military College, Canada.

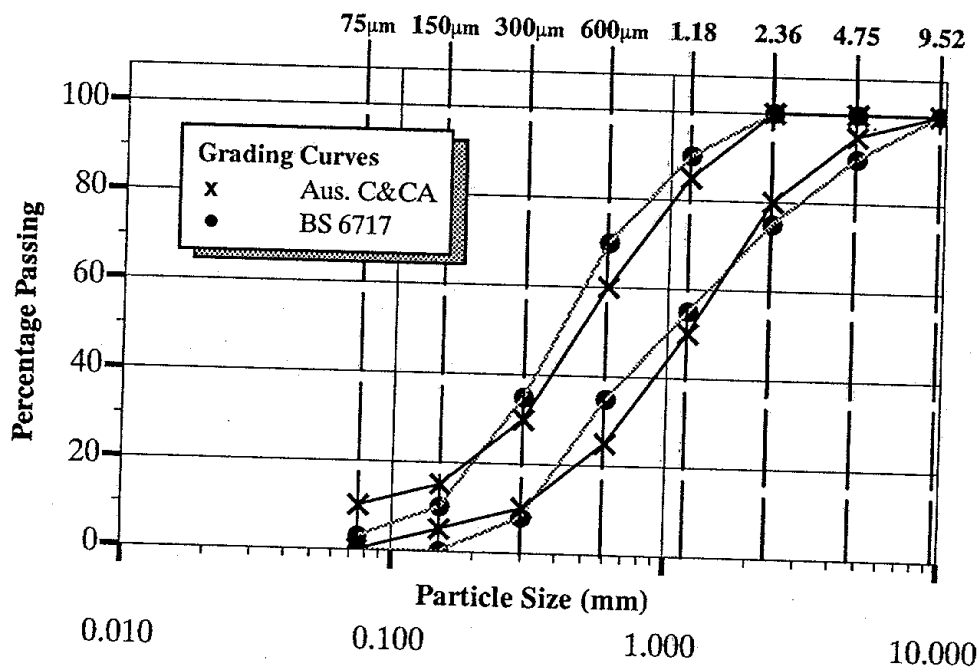
Figure 1 — Bedding Sand Grading Envelopes

Typical sand grading envelopes from Australia and the U.K. are shown in Figure 1. Other gradings have been developed in the United States and these are summarised in Table 1. In the Netherlands, particularly for mechanical laying, a coarser mixture of sand and fine gravel, having an upper size limit of 8mm, is generally used, but in that case many of the particles will be too large to enter a 2 to 5mm wide joint. In most other countries an upper size limit of 5mm is specified.

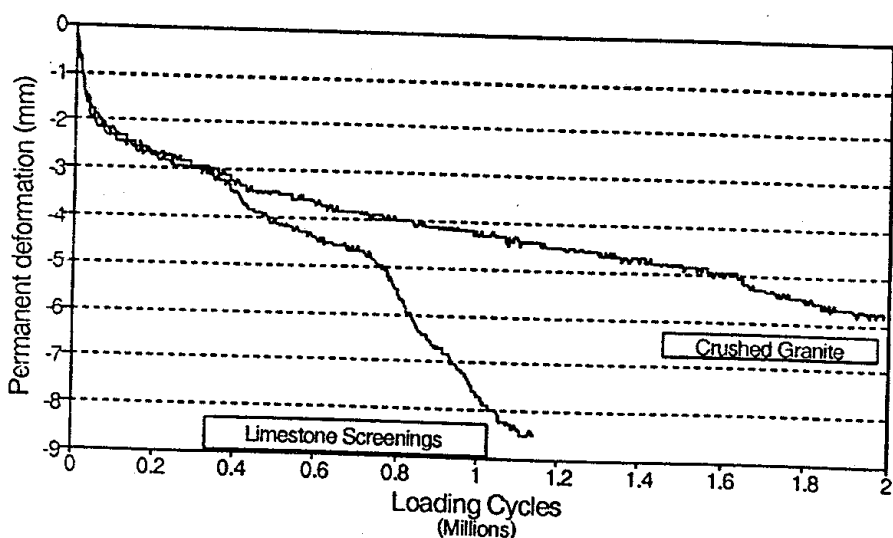
Figure 2 — Load versus deformation, flooded pavement

obtained from different sources in Canada and the United States. Physical and mechanical properties have been measured and selected sands are being used in trial, laboratory pavements loaded vertically, at 5Hz through a 300mm diameter steel plate. The loading sequence is shown in Table 2. If this loading sequence is completed without producing more than 13mm permanent vertical deformation, the pavement is flooded to the top of the pavers and loading at 40kN continued at 5Hz for a further two million cycles or until prior failure. Figure 2 shows the load-deformation relationship for limestone screenings and for crushed granite during the flooded phase of the tests. Limestone screenings were pumped out through the joints and a permanent vertical deformation of 8mm was reached after one million wet cycles, whereas the crushed granite had reached a deformation of only 6mm after two million cycles. Table 3 shows particle size distributions for dry samples of limestone screenings, crushed granite and natural silica sand before and after the mechanical degradation test. It can be seen that neither the granite nor the limestone meet the criteria proposed by Dowson.
