A SURVEY OF AUSTRALIAN CONTAINER PORT PAVEMENTS SURFACED WITH CONCRETE SEGMENTAL PAVING

Shackel, B., Pearson, A. and Holt, W.

School of Civil and Environmental Engineering, University of New South Wales,
Queensland, Australia.

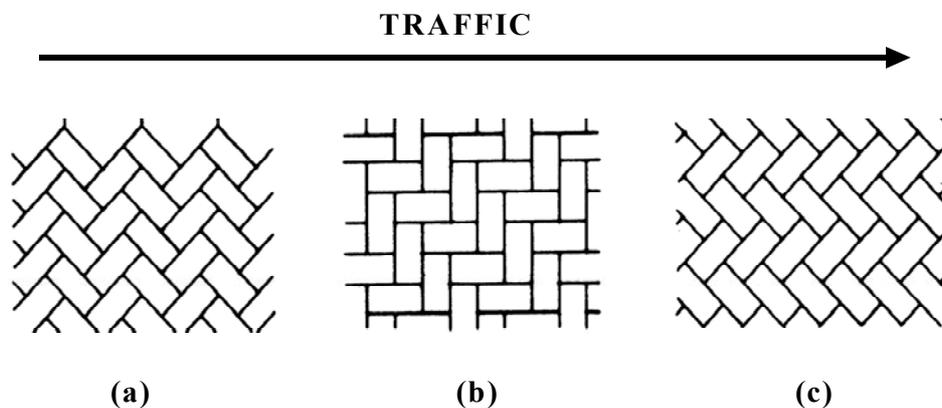
In all cases, the pavers comprised hand-layed 80mm thick shaped Category A pavers installed in herringbone pattern. It was observed that the orientation of the pattern with respect to the dominant direction of traffic was not always optimal. Tests have shown that the direction of the herringbone pattern has an influence on performance (Shackel, 1990). With reference to Figure 1, pattern (a) has been shown to be associated with less rutting than pattern (b).

Figure 1. Orientation of herringbone pattern relative to traffic with (a) best and (c) worst.

By referring to Figure 1 it may be seen that, for the pavement shown in Figure 2, the orientation of the herringbone pattern to the left of the drain with respect to the dominant direction of trafficking was the least advantageous possible. Here, rotation of the bond through 90° would have acted to reduce rutting under traffic caused by the transtainer. Inconsistently, the pattern show to the right of the drain in Figure 2 is optimally aligned for transtainers or straddle carriers moving along the container rows. Although the pavements were not specifically designed for transtainer operation this demonstrates the need to take care when establishing the orientation of laying patterns during design and construction and is discussed further below.

This study suggests that there is a need for designers to be encouraged to give more attention to the orientation of herringbone laying patterns when very heavy wheel loads such as those applied by transtainers are to be carried. As noted above, a common situation is that the mode of operation may change after the pavement enters service e.g. from FLT movements to straddle carrier operations. In such cases, where a change in operation mode may occur, it would be best to choose Pattern (b) in Figure 1 rather than the more optimal pattern (a).
