Tech Spec 7

Interlocking Concrete
Pavement Institute

Repair of Utility Cuts Using Interlocking Concrete Pavers

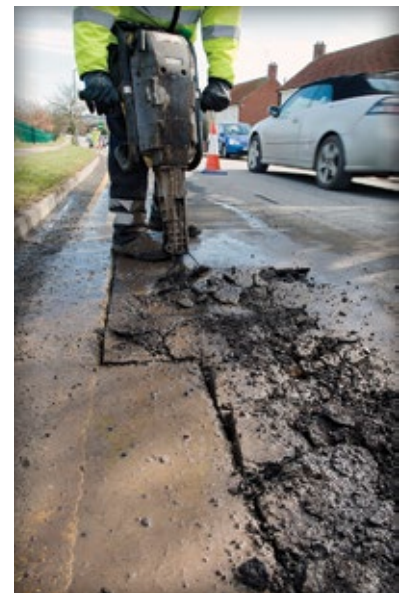
Figure 1. Repairs to utilities are a common sight in cities, incurring costs to cities and taxpayers.

North American cities have thousands of utility cuts made in their streets each year. Figure 1 shows a daily occurrence in most cities: repairs to underground utility lines for water, sewer, gas, electric, steam, phone, fiber-optic, or cable services. A sample is given below of the number of annual utility cuts in a few cities.

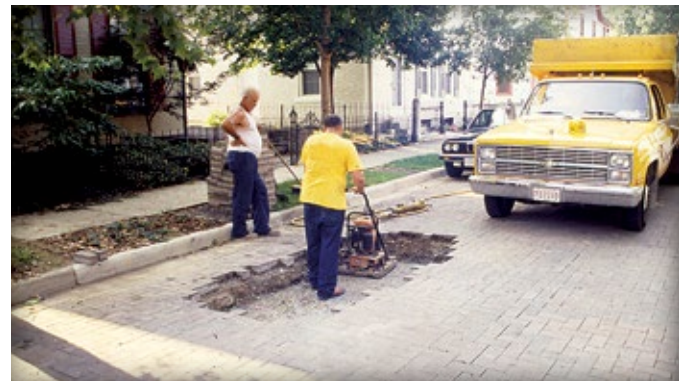
Figure 3. Compaction of the base

Figures 2, 3, 4, 5 and 6 show the process of repair and illustrate the continuity of the paver surface after it is completed. The reinstated units are knitted into existing ones through the interlocking paving pattern and sand filled joints. Besides providing a pavement surface without cuts, the joints distribute loads by

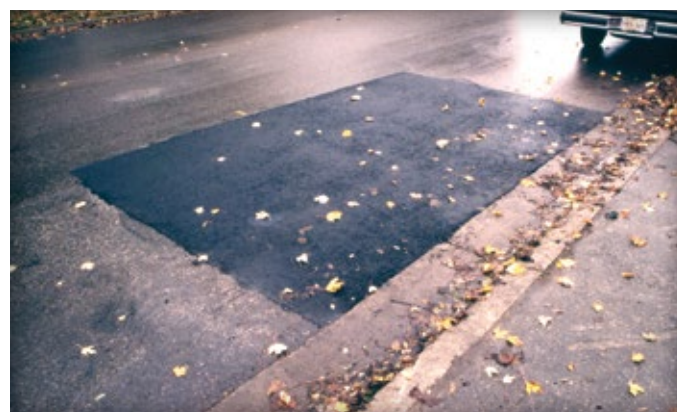
Figure 7. Pavement damage from settlement and shrinkage of cold patch asphalt.

Figure 7 shows the result of settlement and shrinkage of the cold patch asphalt in a London, Ontario, utility cut. The change in dimensions causes the edge of the cut asphalt to deteriorate, and settlement decreases riding quality.

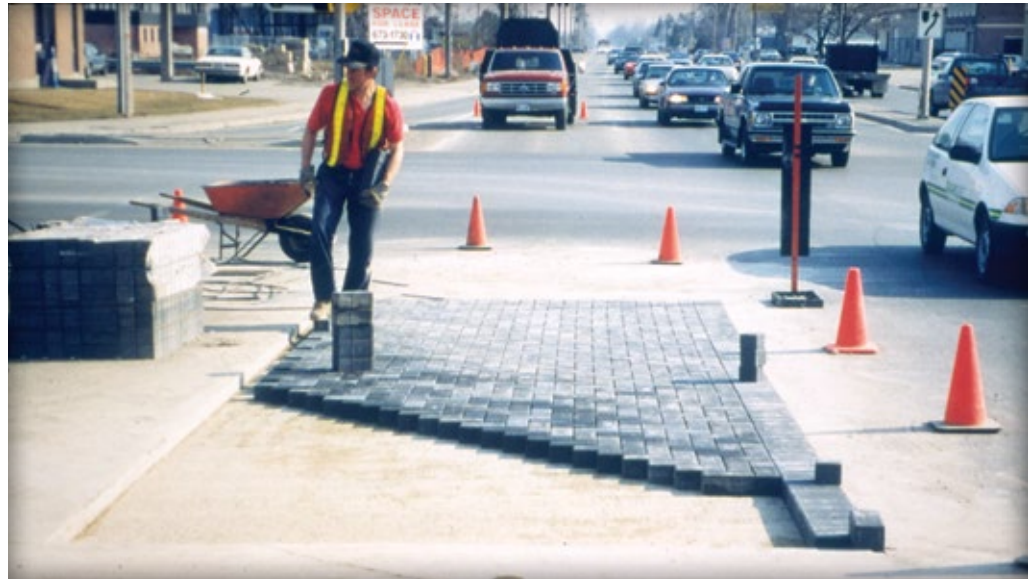
Figure 12. Pavers are laid in a 90 degree herringbone pattern between the border courses.

ers [nominally 4 in. by 8 in. (100 mm x 200 mm)] should be placed against the cut asphalt sides as a border course. They should be placed in a sailor course, i.e., the long side against the asphalt. No cut paver should be smaller than one third of a unit. Place pavers between the border course in a 90 degree herringbone pattern (Figure 12). Joints between pavers should be between $\frac{1}{16}$ and $\frac{5}{16}$ in. (2 to 5 mm). Compact the pavers with a minimum 5,000 lbf (22 kN) plate compactor. Make at least four passes with the plate compactor. A small test area of pavers may need to be compacted to check the amount of settlement. The bedding sand thickness should
