Your requested ICPI Tech Spec **07** follows this page.

Repair of Utility Cuts Within Interlocking Concrete Pavements

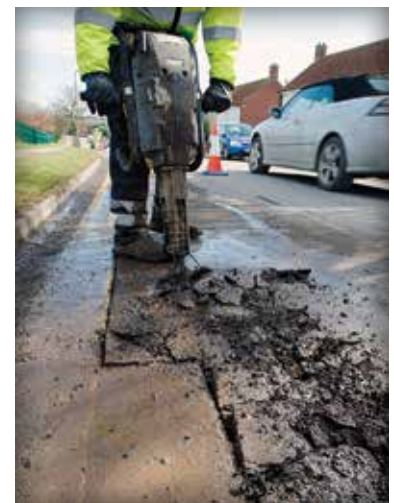
Figure 1. Repairs to utilities are a common sight in cities, incurring costs to cities and taxpayers.

North American cities have thousands of utility cuts made in their streets each year. Figure 1 shows a daily occurrence in most cities: repairs to underground utility lines for water, sewer, gas, electric, steam, phone, fiber-optic, or cable services. A sample is given below of the number of annual utility cuts in a few cities.
