USE OF CONCRETE PAVERS AS A ROADWAY STANDARD FOR THE CITY OF RIPON

Matt Machado, P.E., MBA
City Engineer
City of Ripon, California
mmachado@cityofripon.org

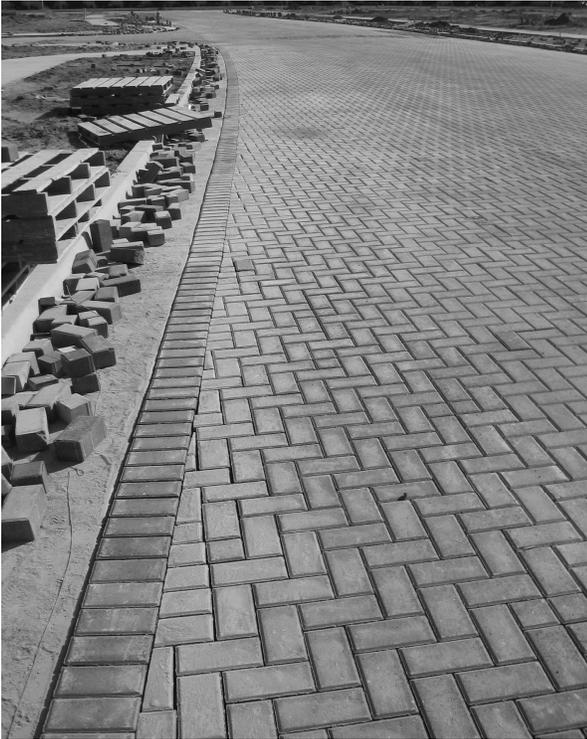
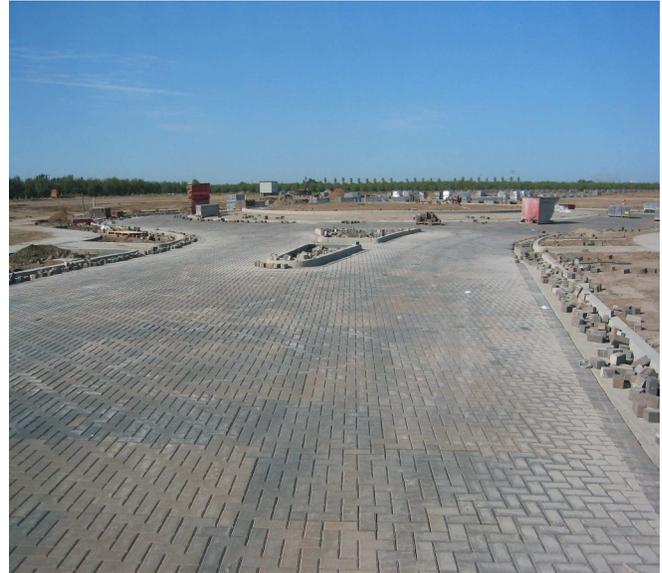
Figures 1 and 2. 2006 construction views of a residential subdivision entrance.

At writing, there are four residential subdivisions under construction using concrete paver roads. The total paver roadway area to be completed by the fall of 2006 is approximately 100,000 m². In addition, multiple commercial projects will be constructing portions of new roadways also with concrete pavers. Some of these roadways will be major arterials, if not expressways, having vehicle speeds of 55-70 kph and high traffic volumes. Figures 2 and 3 illustrate concrete paver roads under construction.
