# **PORT OF OAKLAND - THE LARGEST BLOCK PAVING PROJECT IN THE WESTERN HEMISPHERE**

## **SUMMARY**

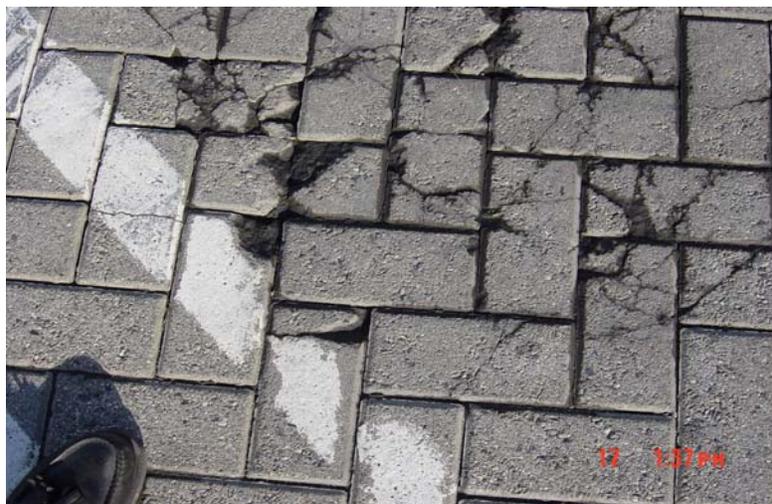
**Figure 1. Showing typical damage under corner castings. This type of damage has caused no loss of service.**

Over the years there has been some breakage of pavers by the operating equipment. However, the surface has remained waterproof and in no case has this resulted in any loss of service to TraPac. The weight from stacked containers can total as much as 90,700 kg (200,000 lbs.), or 50,000 kg (22,700 lbs.) concentrated by the corner castings, each barely a square foot (0.10 m<sup>2</sup>) in area. While there has been damage at Berth 30, (as there has been at all the installations) it has not resulted in loss of service.

- Close construction monitoring of the work is required.
- Damage due to corner castings does not typically require replacement unless there is an associated subgrade failure.

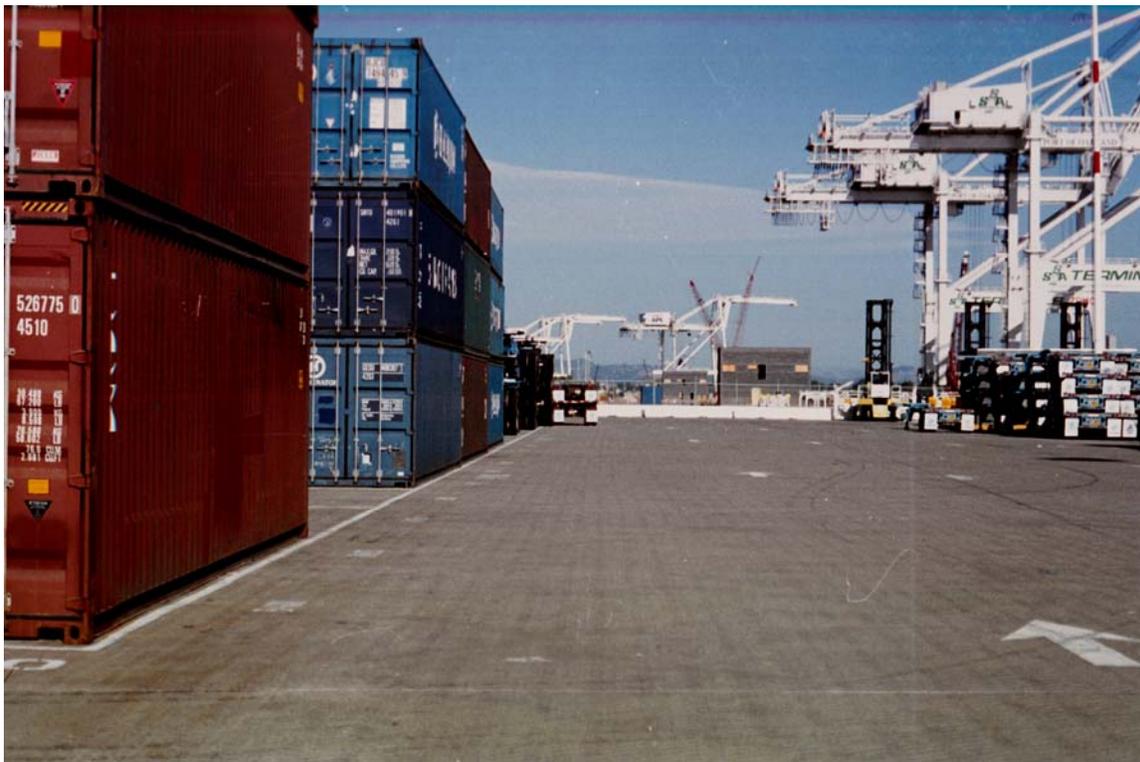
**Figure 2. A view of the completed Berth 55/57 project**

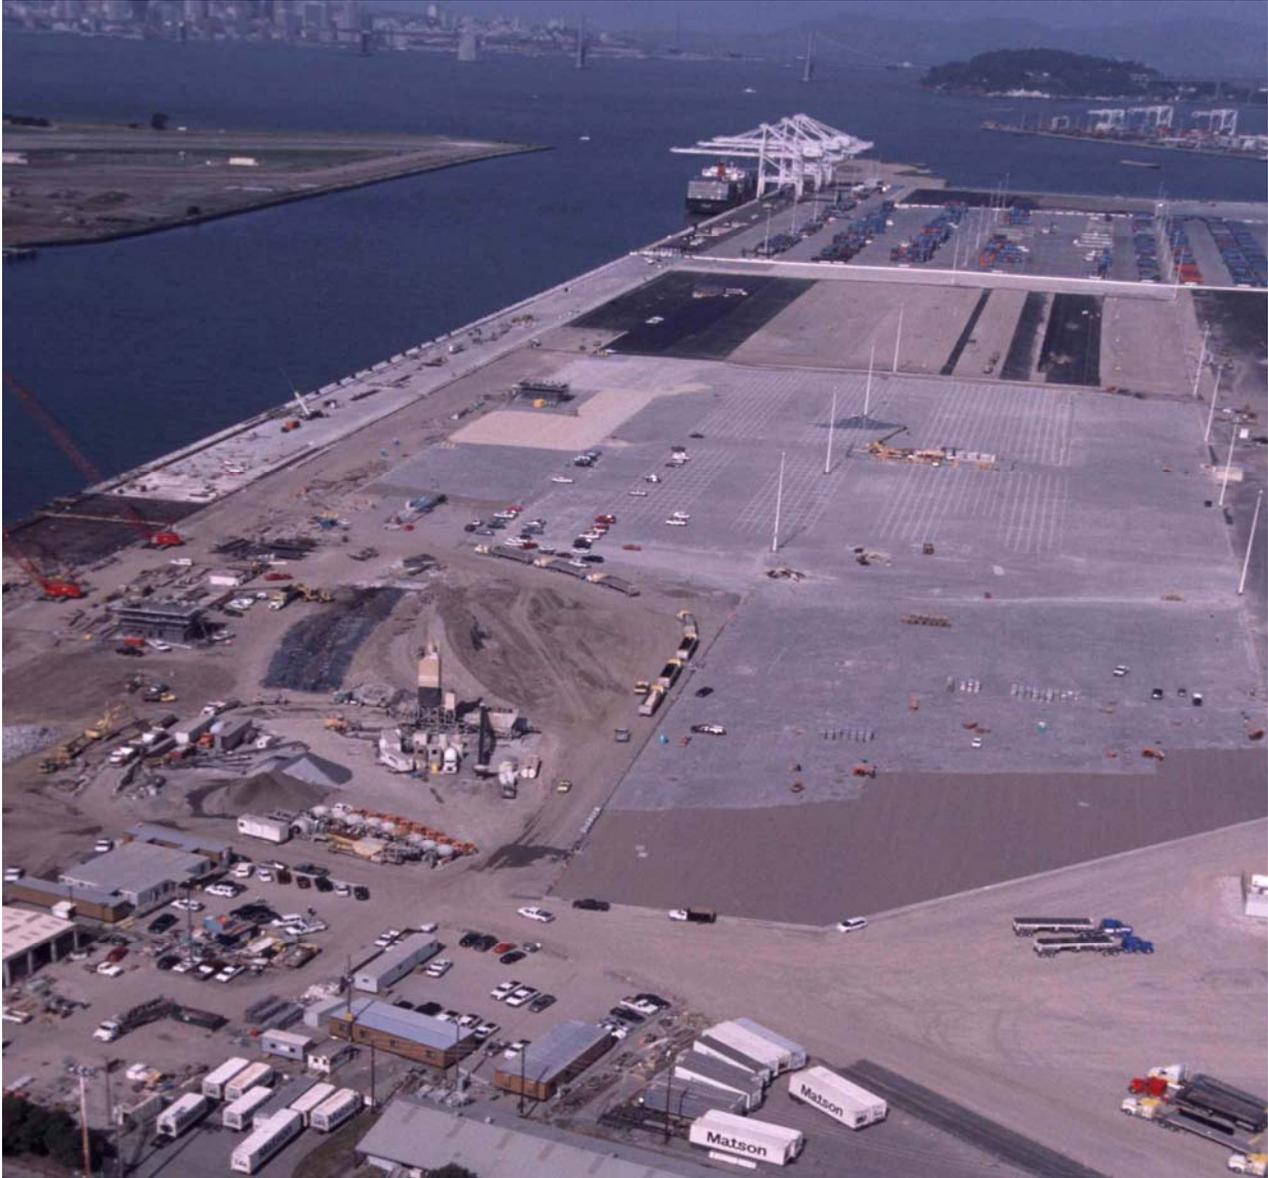
**Figure 3. Showing a view of the construction at the Berth 57/59 Project**
